CONCEPTUAL PLAN VIEW OF STORMWATER DRAINAGE SYSTEM

OPERABLE UNIT #2, VB 170 SUPERFUND SITE

Figure D-2
CONCEPTUAL STORMWATER CHANNEL
CROSS-SECTION
OPERABLE UNIT #2, VB 170 SUPERFUND SITE

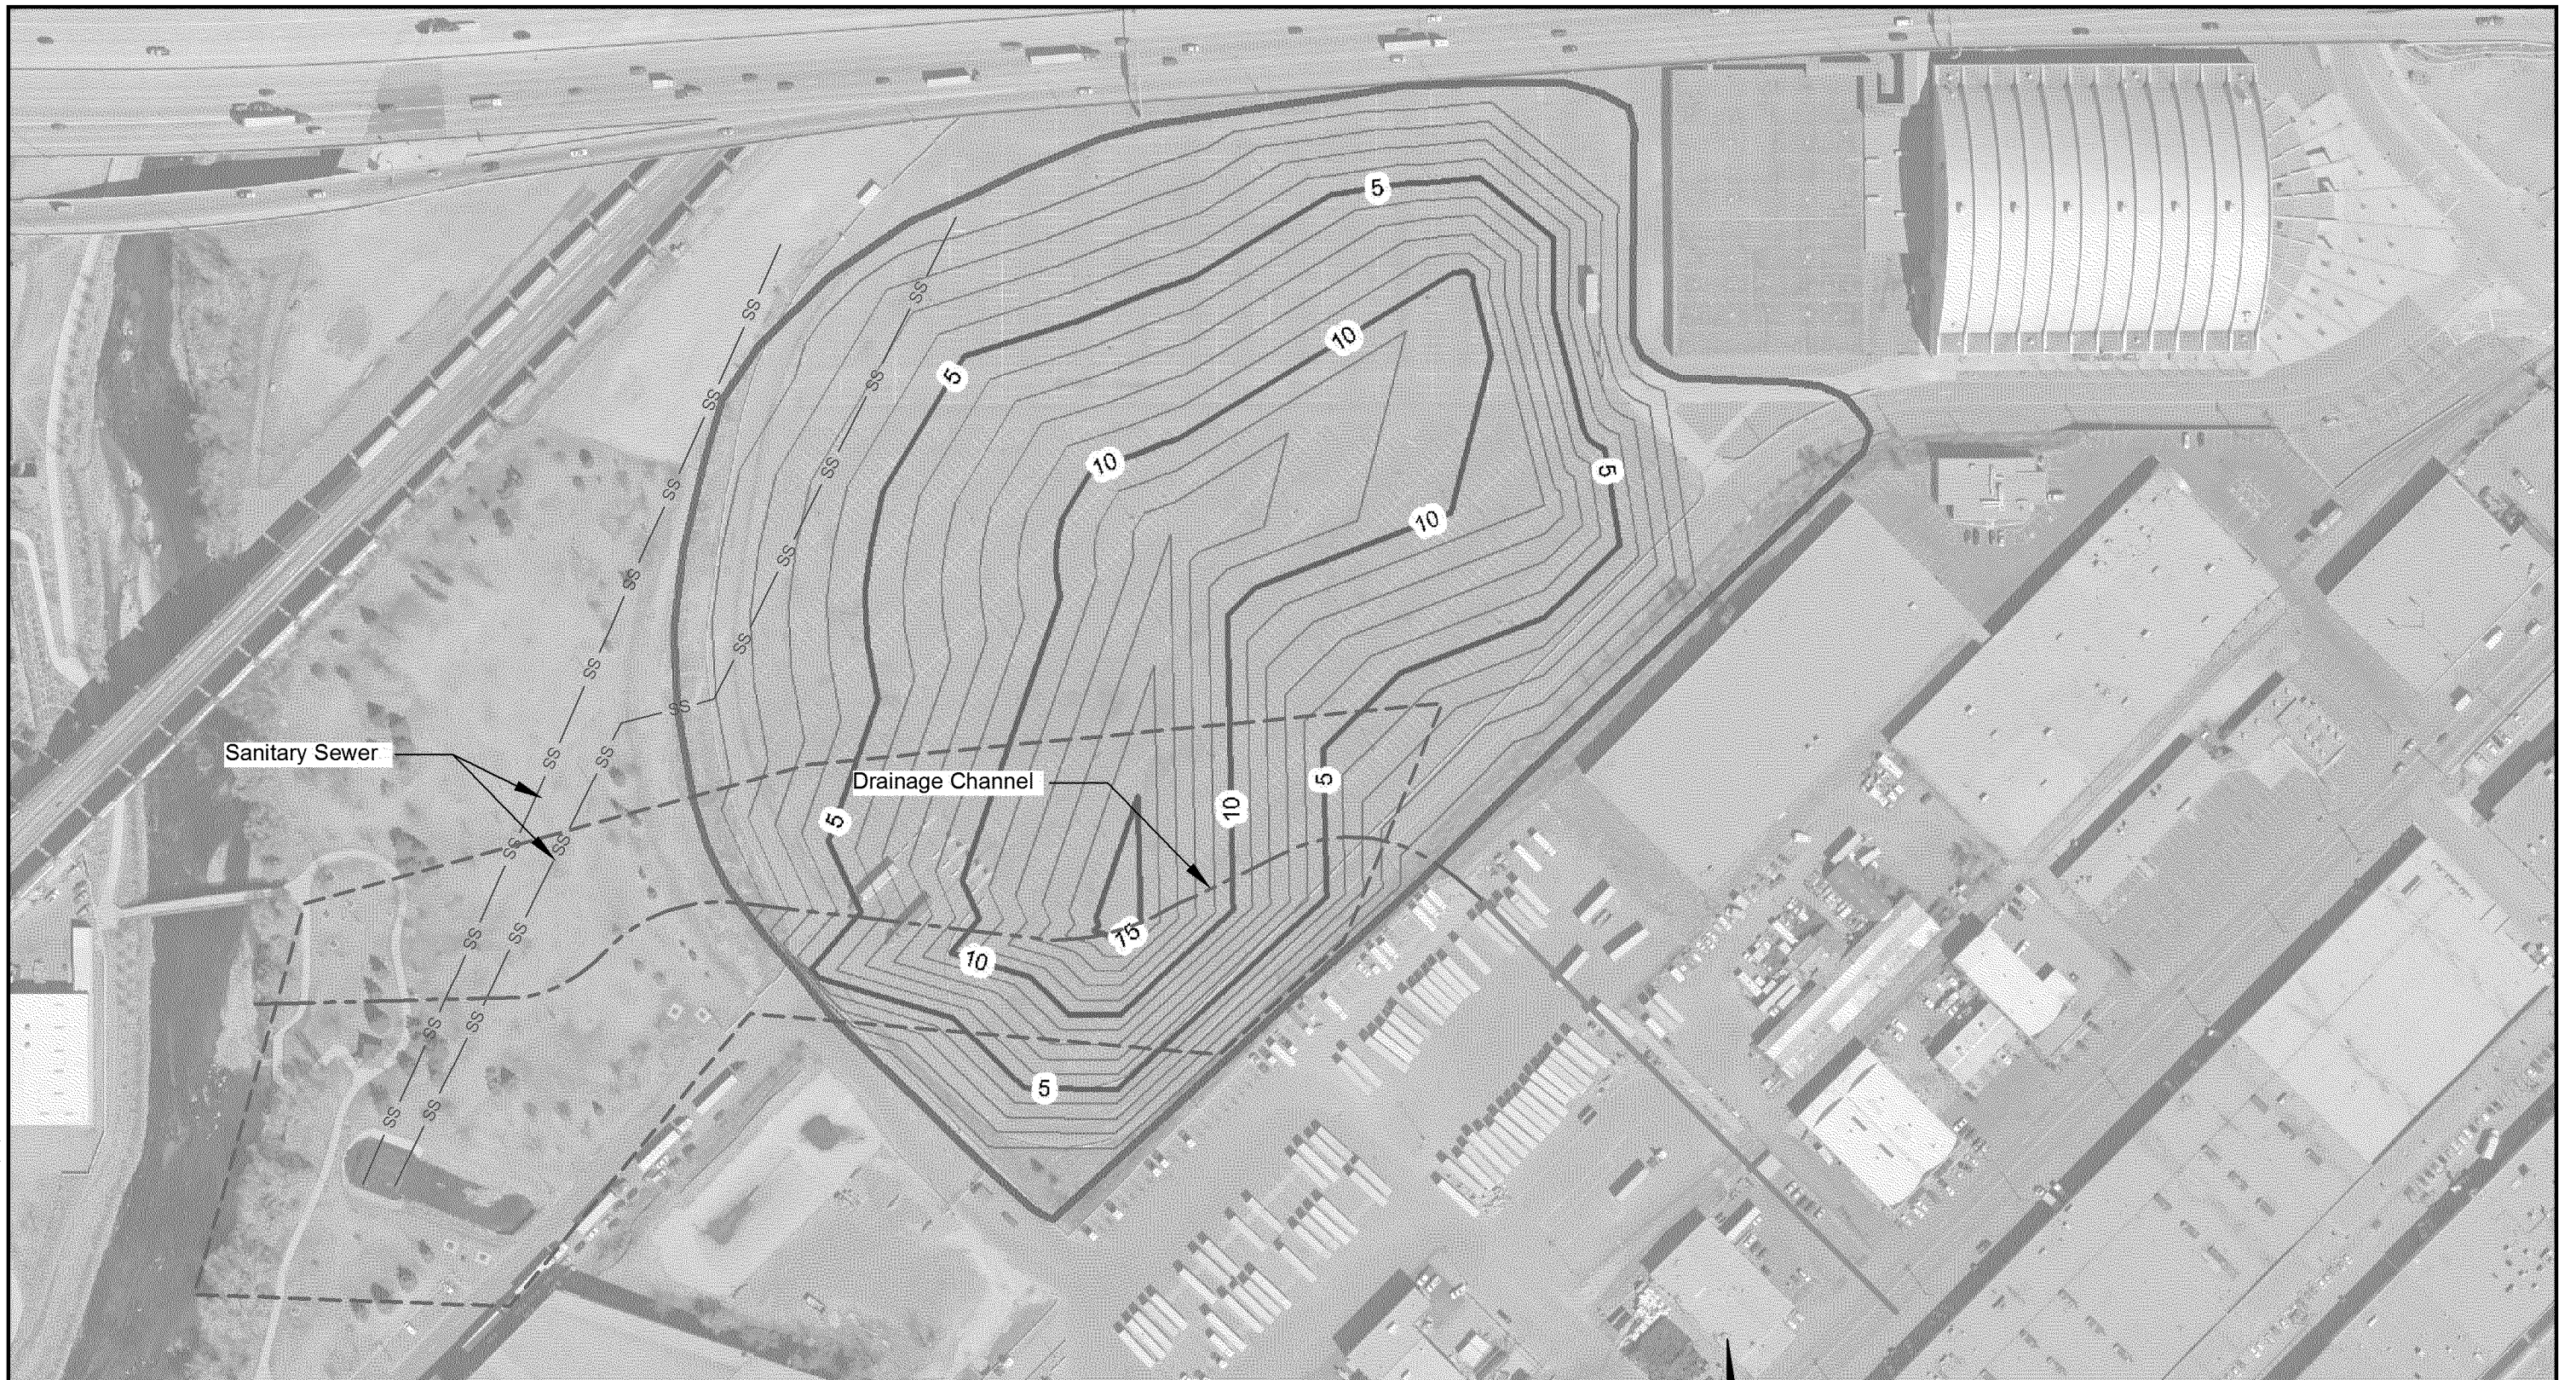
Figure D-1

Limits of Fill Material Within the Coliseum Parking Area as Defined During the OU2 Remedial Investigation (EMSI, 2009)
	Thickness of Fill Material Based on EMSI 2009 Remedial Investigation
	Option 2 - High Street Outfall Alignment
	Drainage Channel
	Sanitary Sewer

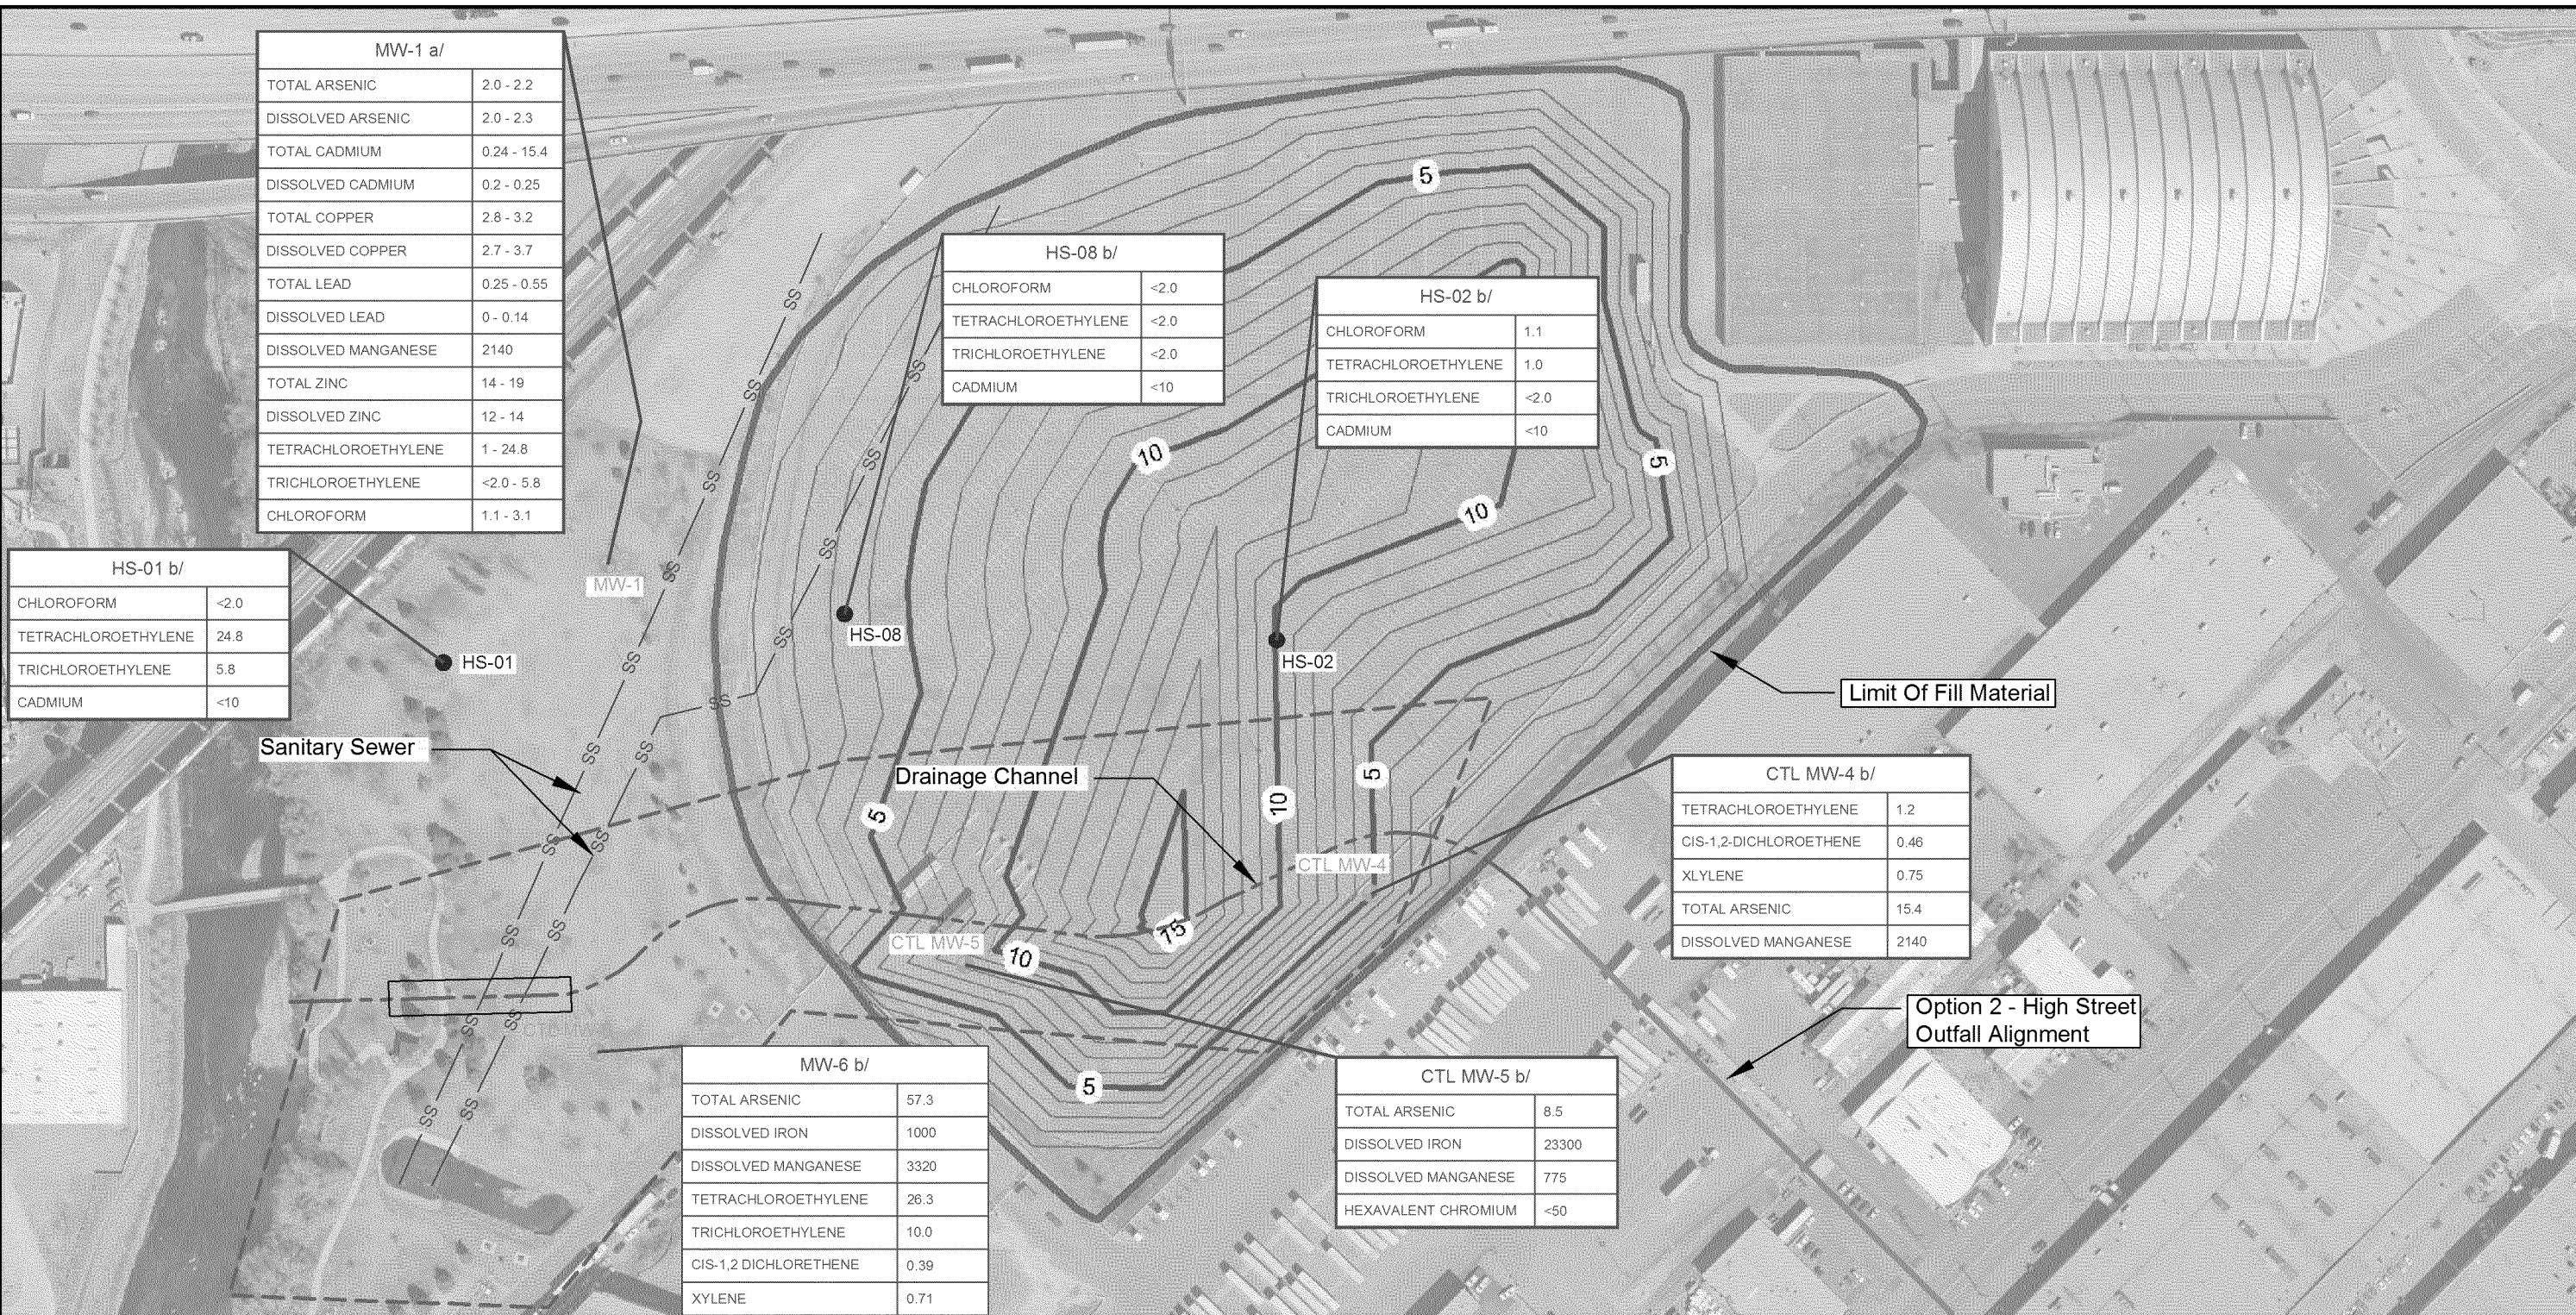
- Monitoring Well
- Soil Boring
- Limits of Fill Material Within the Coliseum Parking Area as Defined During the OU2 Remedial Investigation (EMSI, 2009)
- Thickness of Fill Material Based on EMSI 2009 Remedial Investigation
- Option 2 - High Street Outfall Alignment
- Drainage Channel Sampling Area
- Sanitary Sewer

Note: Results presented in micrograms per liter (ug/L).
a/ EMSI, 2009
b/ CTL Thompson, 2011

Figure D-4
**GROUNDWATER
COMPOUNDS OF CONCERN**
OPERABLE UNIT #2, VB I70 SUPERFUND SITE
